Re: February 2011 Monthly Progress Report
Administrative Settlement Agreement and Order on Consent for Removal Action
U.S. EPA Region 10 Docket No. CERCLA 10-2009-0255
Gasco Sediments Site within the Portland Harbor Superfund Site

Attachment A – Monthly Visual Monitoring Report for Pilot Cap Vicinity

Visual Observations Log Form

Monitoring Period: Monthly(Year 5) — February 2011

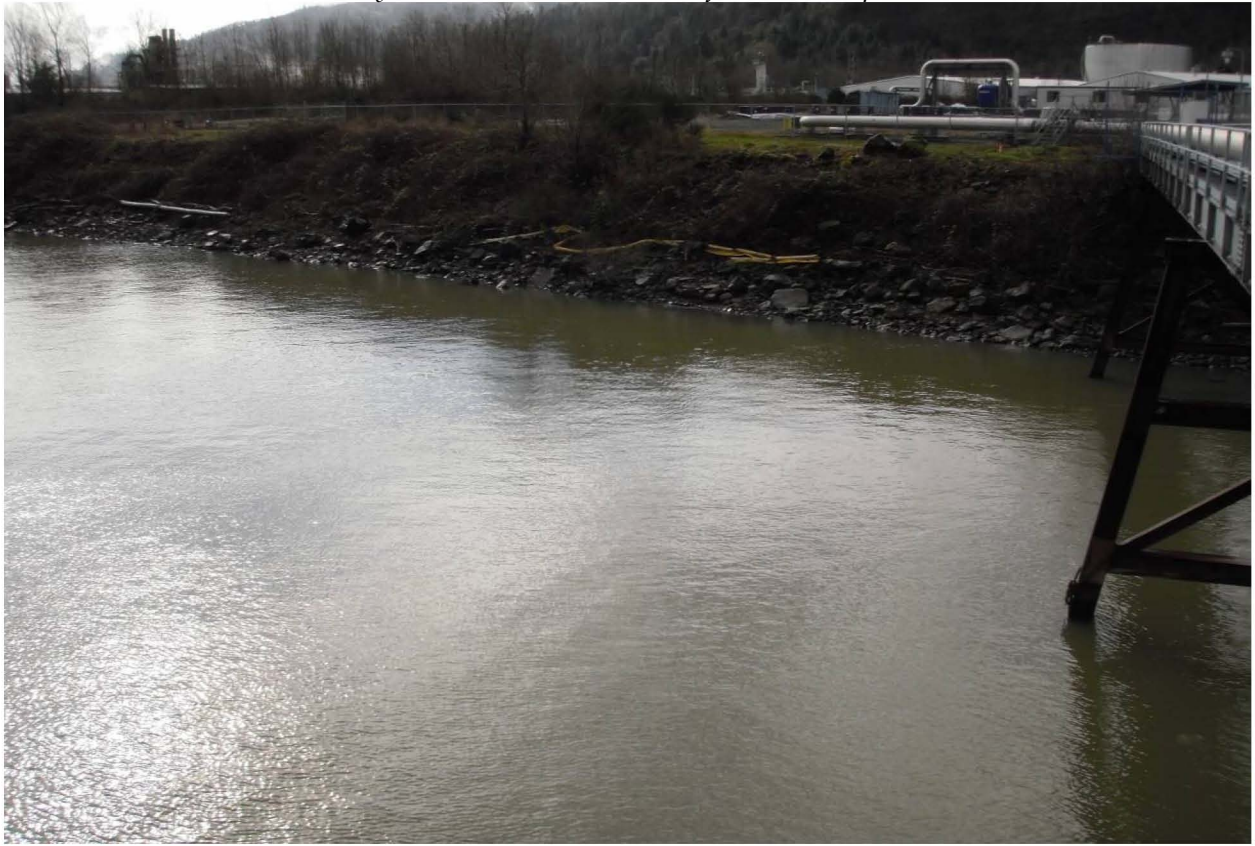
Observations of Erosion/Deposition: No erosion/deposition is evident along the shoreline. Due to high river water levels, the exposed organo- clay mat material observed in preceding events was not visible (Photo 1).

Photo 1 — *River level currently elevated above the extent of sediment cap (02/22/11):*

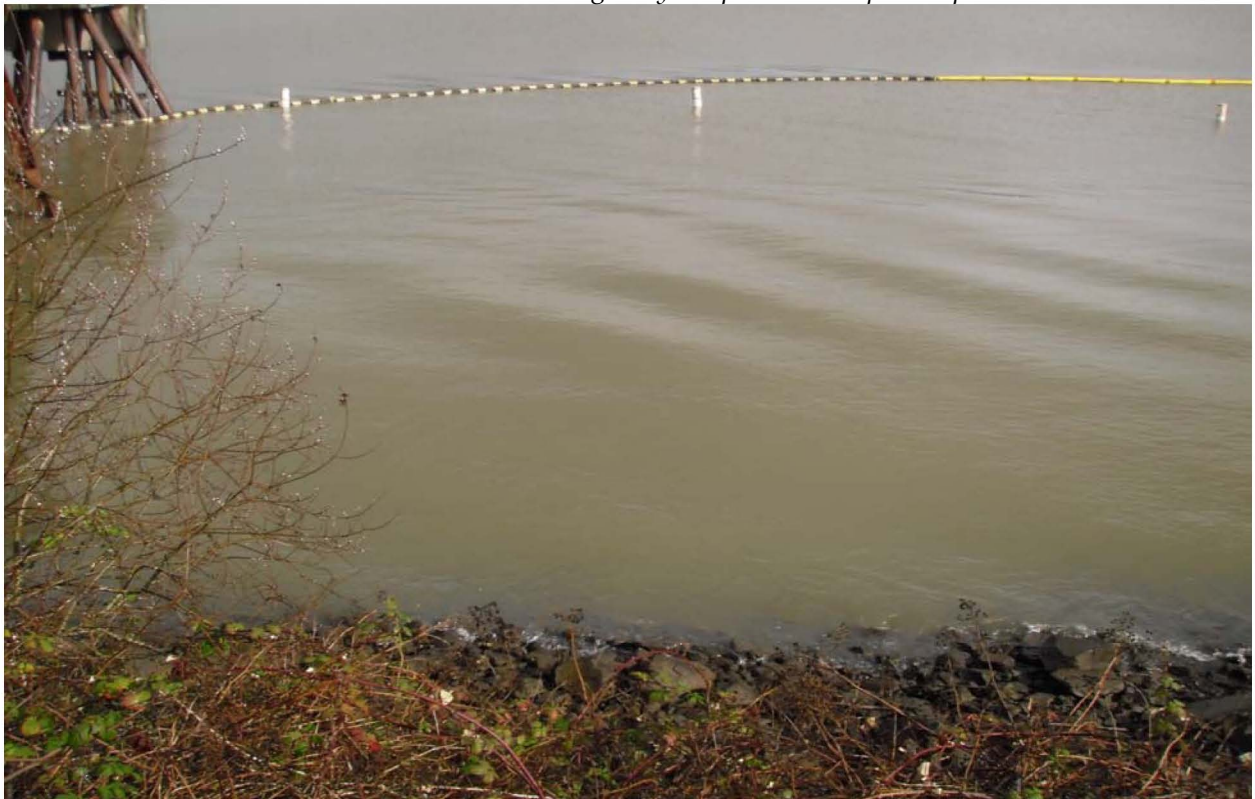
Observations of Long-term Controls (i.e., oil booms, organo-clay mat, etc.) The Fuel and Marine Marketing (FAMM) containment boom is positioned across the cap area, between the upriver corner of the ship dock and the wooden dolphin (near the upriver extent of the site and near the Siltronic Corporation outfall). Buoys that identify the cap area to mariners are in place as installed. The position of the FAMM oil boom, warning buoys and a general overview of the site shoreline are shown in Photo 2.

Photo 2 — *FAMM oil boom and mariner warning buoys in place across pilot cap area (02/22/11):*

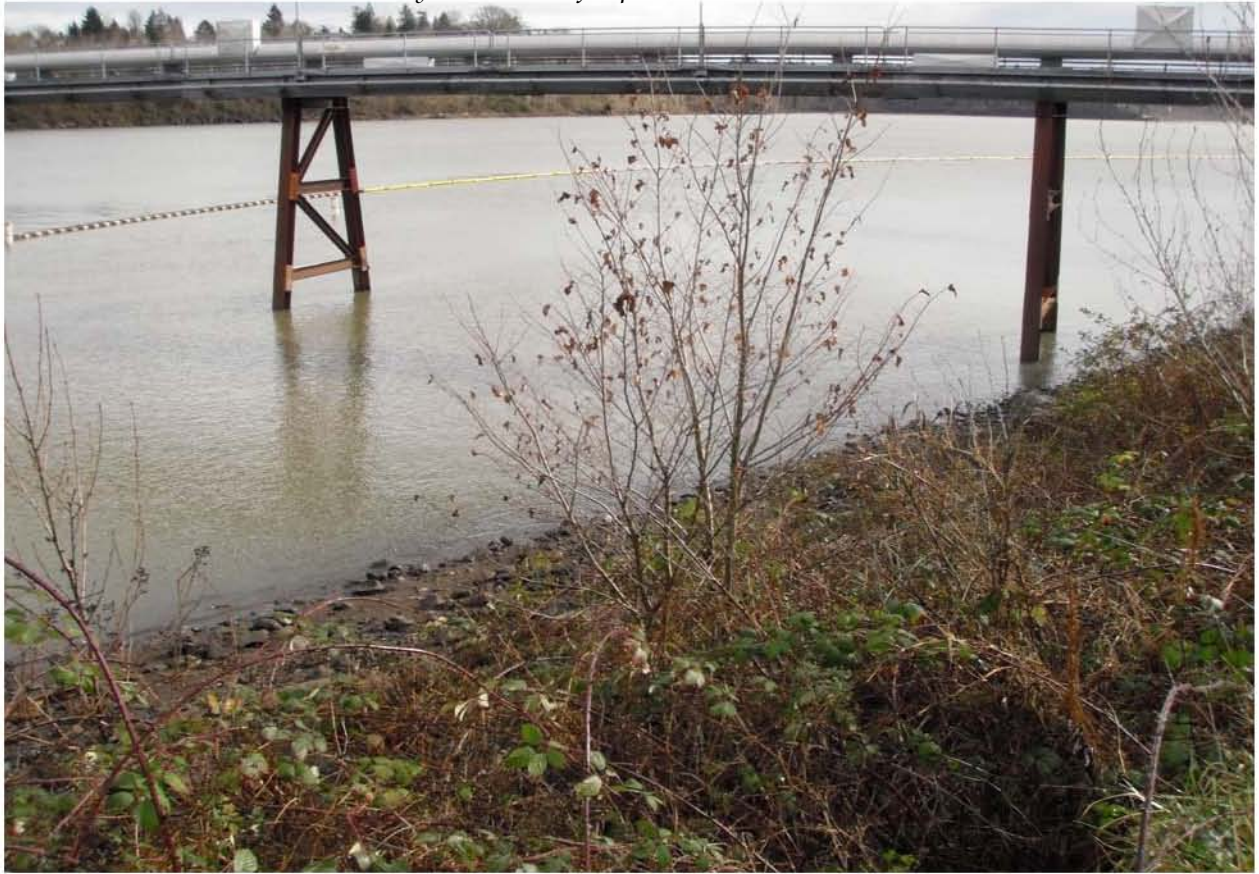
No sheen is evident in or around the cap area. Photo 3 shows the water surface and shoreline immediately downriver of the sediment cap.

Photo 3 — *Conditions immediately downriver of cap area (02/22/11):*
